# SHELTER PROJECTS

## RCRC edition

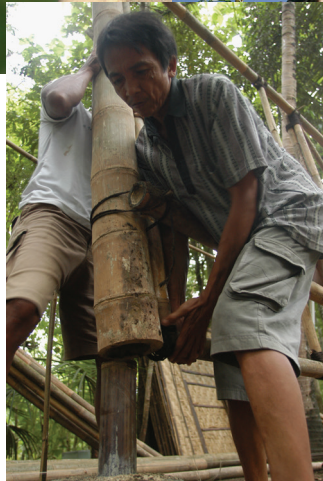
Connecting a vertical post to the foundation

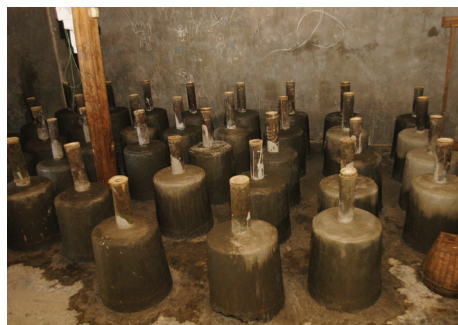
Foundation pads cast with bamboo to connect them to the frame

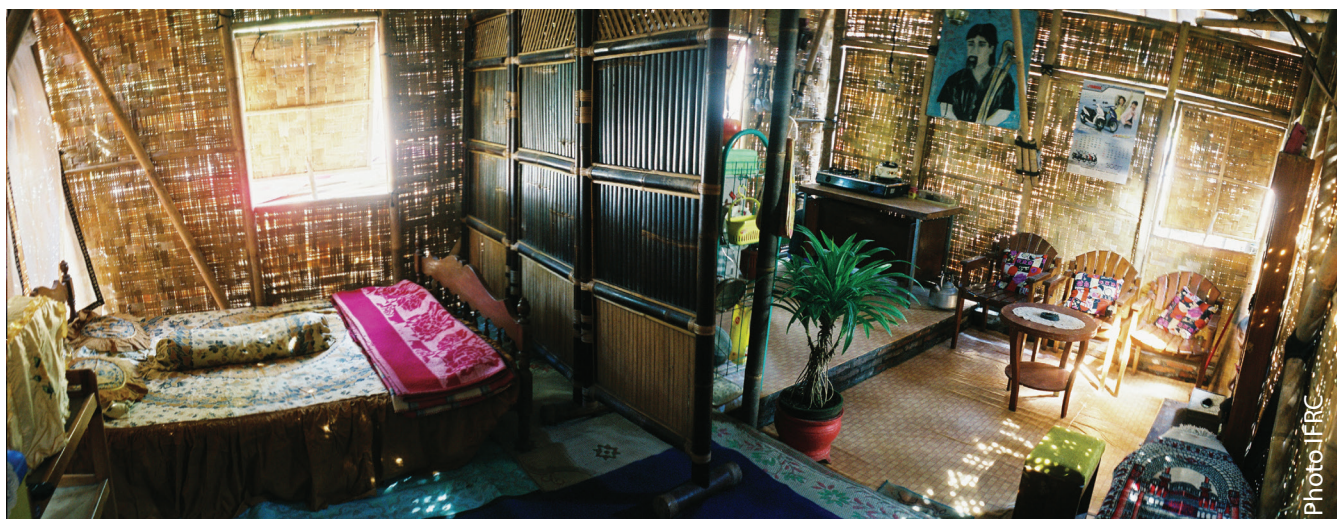
The interior of a transitional shelter

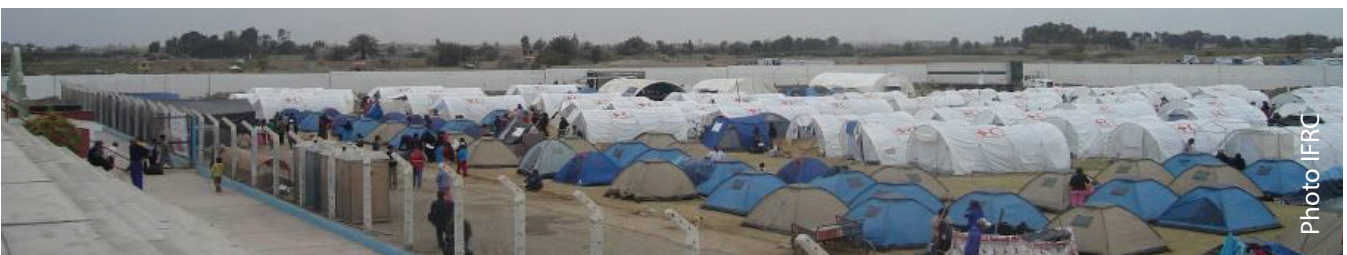
Some people with no other options found short-term shelter immediately after the earthquake in tents and camps.

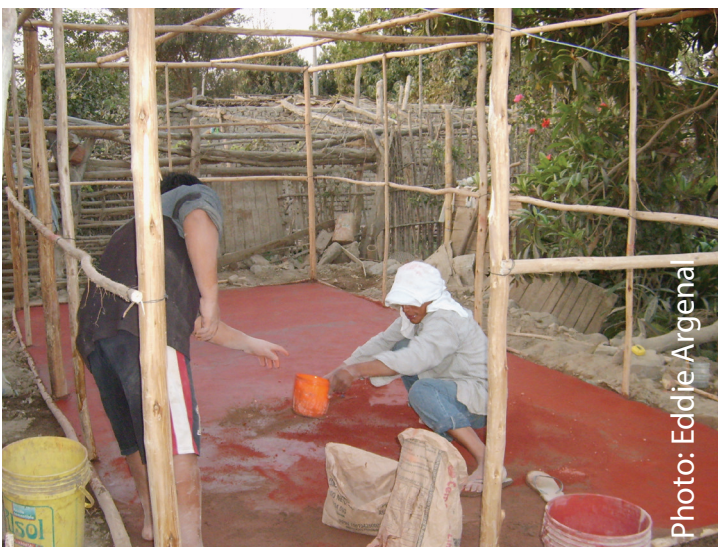
Making the concrete floor slab

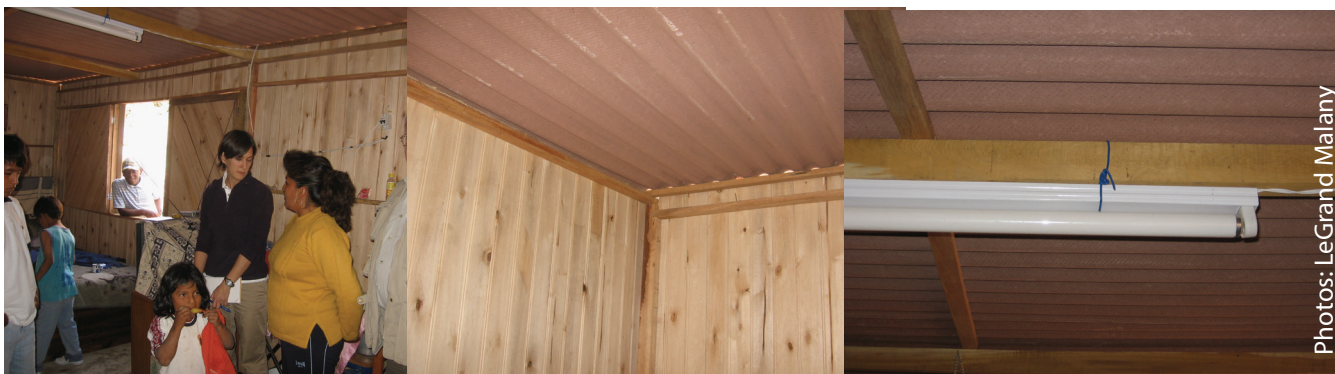
Photos: LeGrand Malany

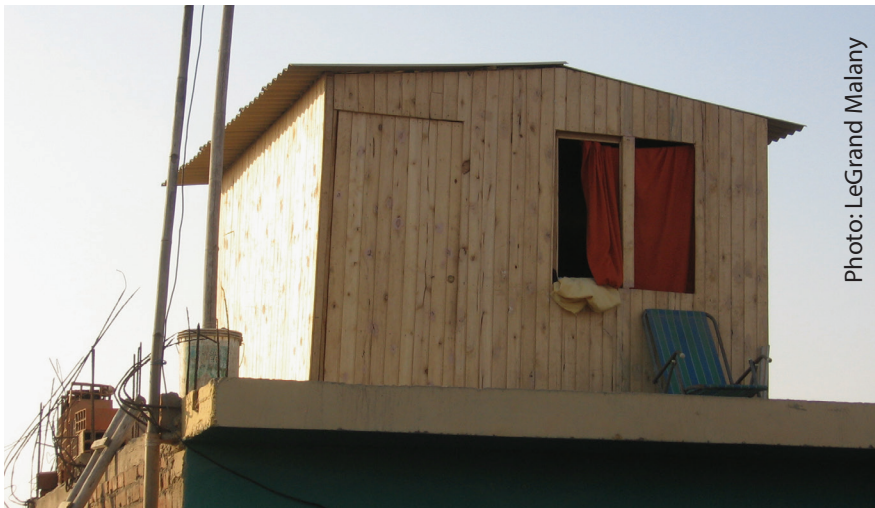
Completed shelter built on the roof of a damaged house

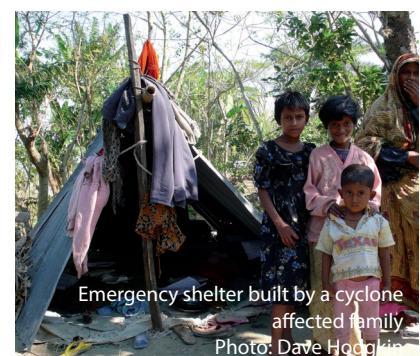
Emergency shelter built by a cyclone affected family  
Photo: Dave Hoogstra

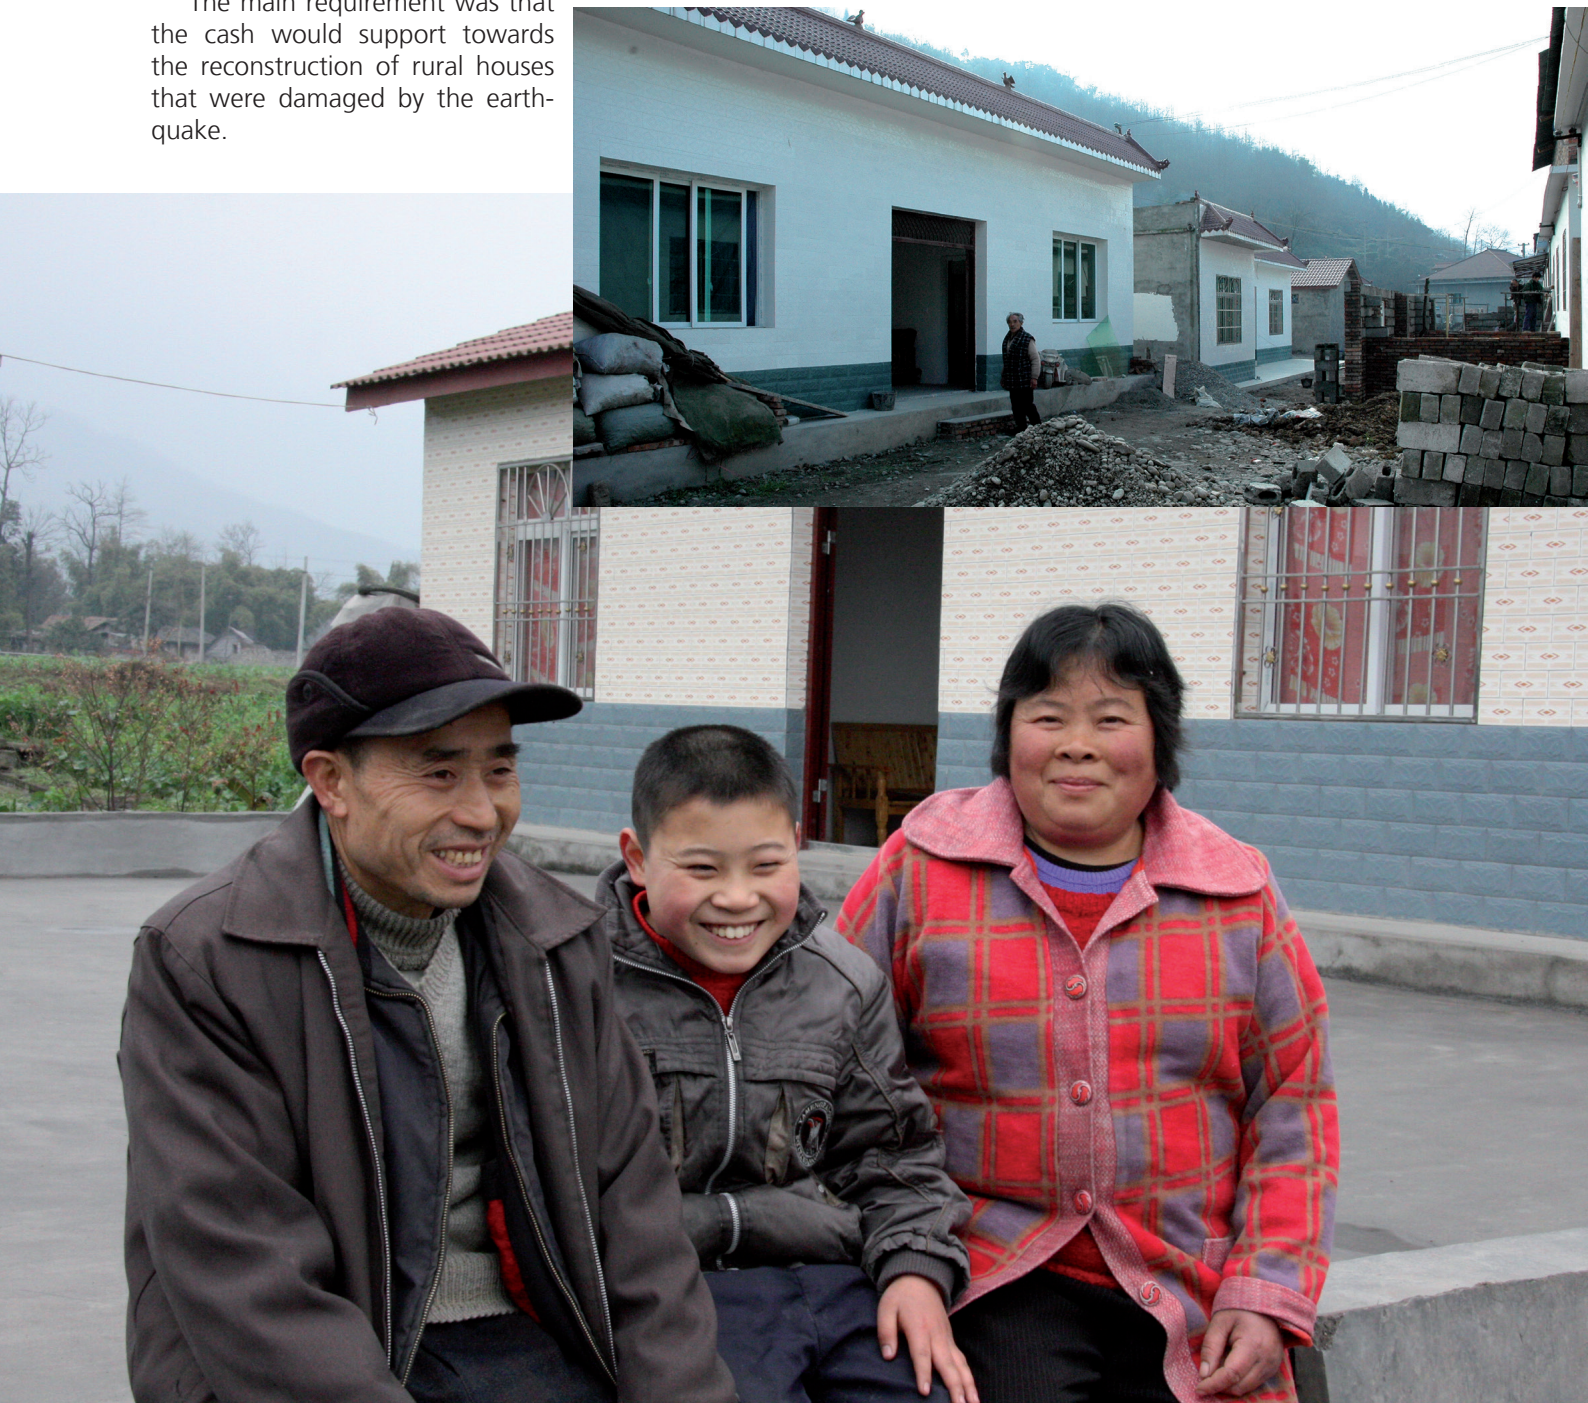
## B.15 Myanmar - 2008 - Cyclone

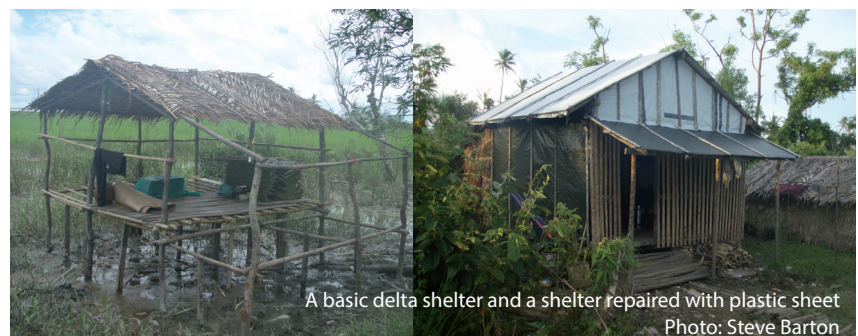
A basic delta shelter and a shelter repaired with plastic sheet  
Photo: Steve Barton

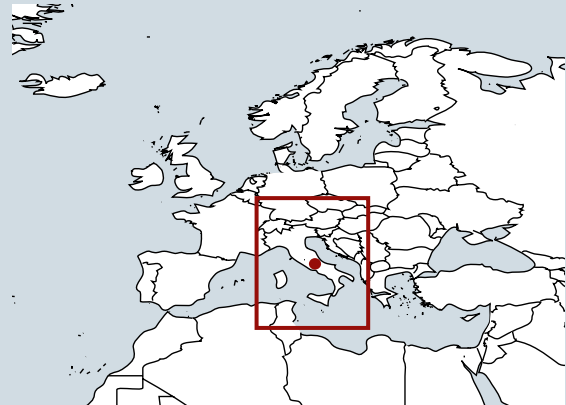
#### Disaster overview

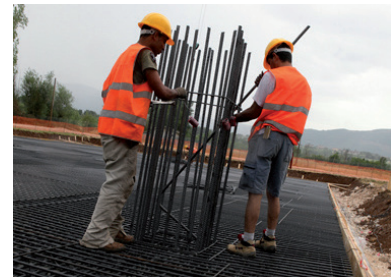
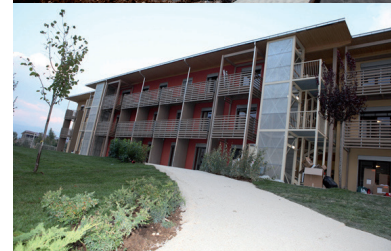
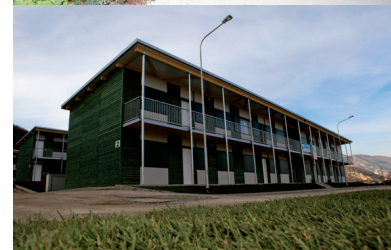
Left: tent camps,  
Centre: modular housing units  
Right: apartment blocks  
Photos: Dipartimento Protezione Civile  
Croce Rossa Italiana

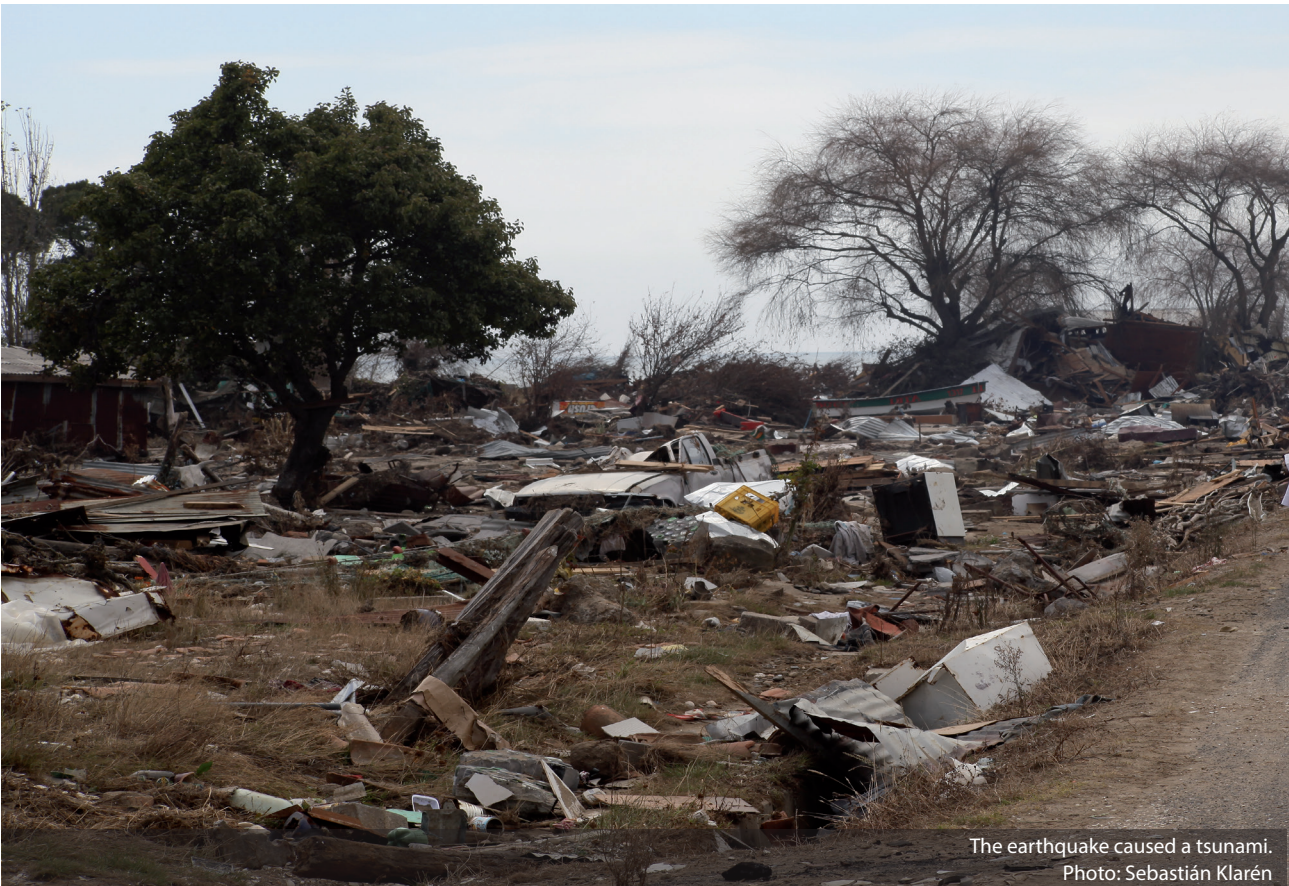
The earthquake caused a tsunami.  
Photo: Sebastián Klarén

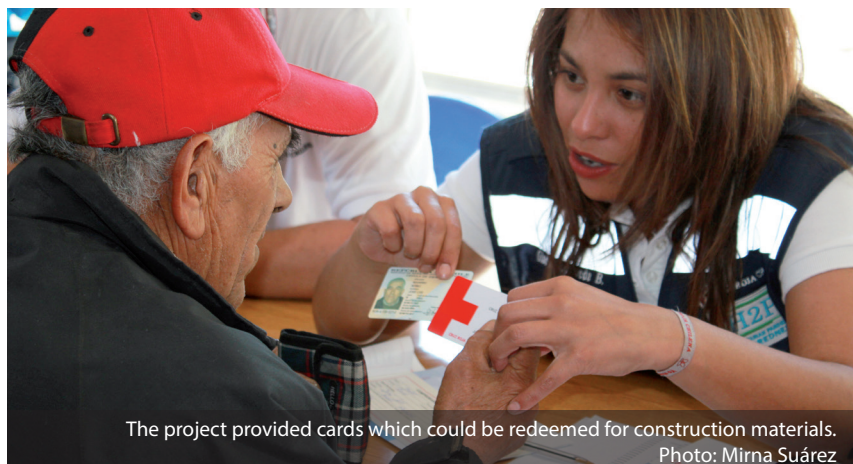
The project provided cards which could be redeemed for construction materials.  
Photo: Mirna Suárez

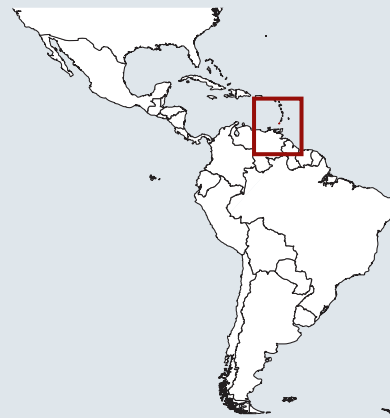
#### Project timeline

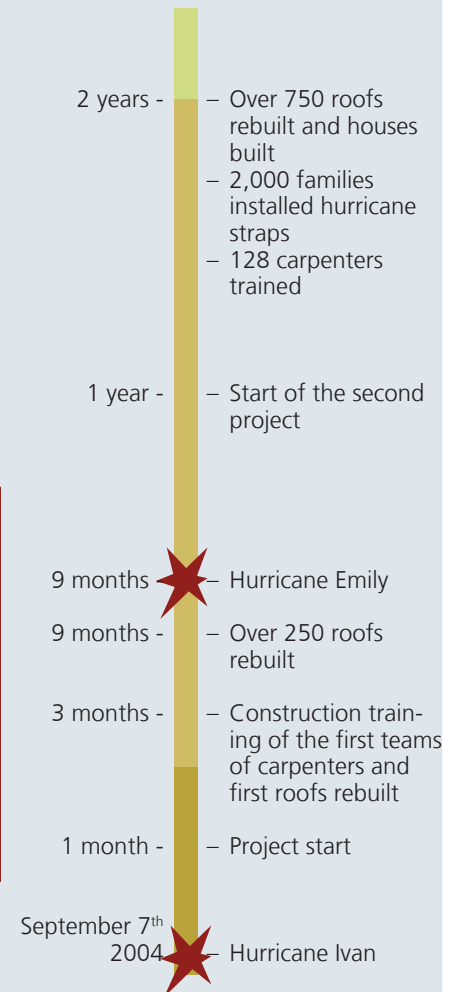
#### Project description

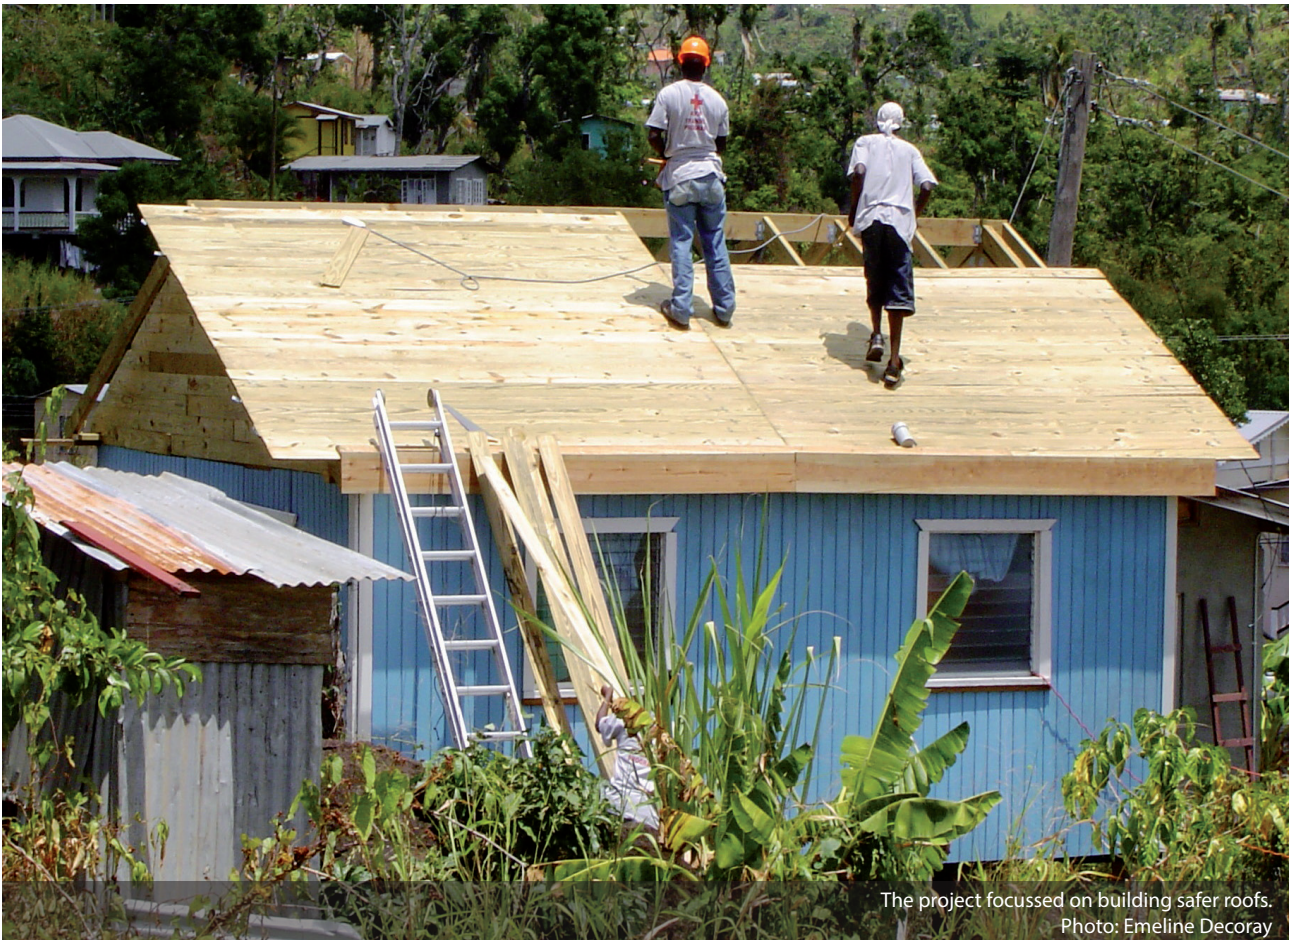
The project focussed on building safer roofs.  
Photo: Emeline Decoray

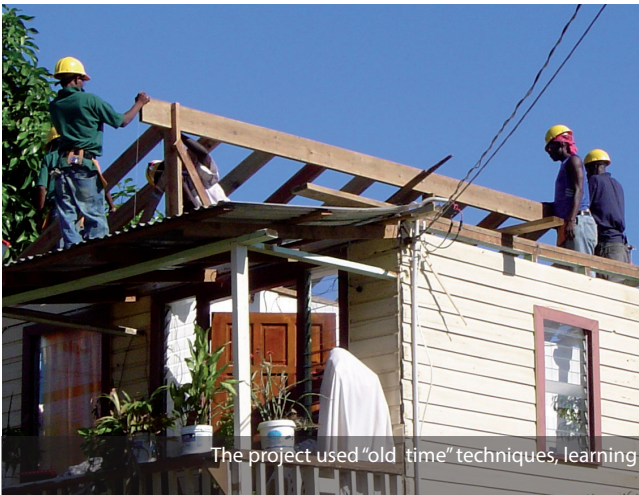
The project used "old time" techniques, learning from the past and which buildings had survived the hurricane and why.

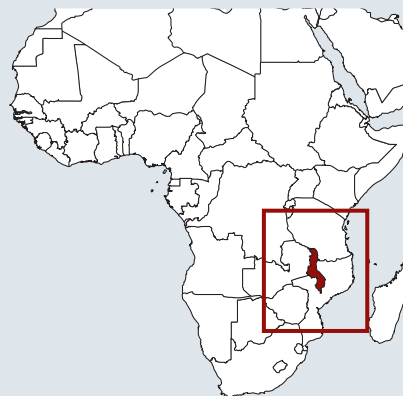
**Project timeline**

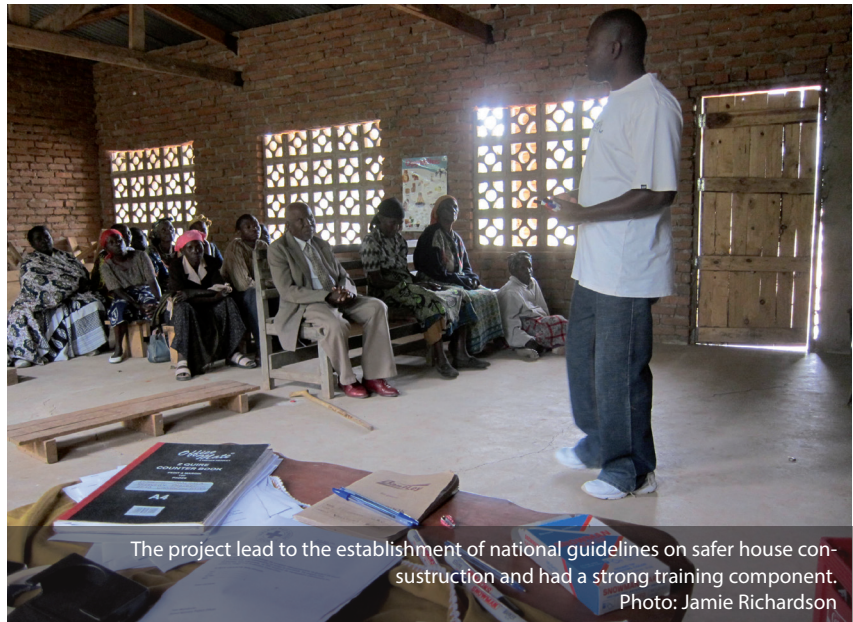
The project led to the establishment of national guidelines on safer house construction and had a strong training component. Photo: Jamie Richardson

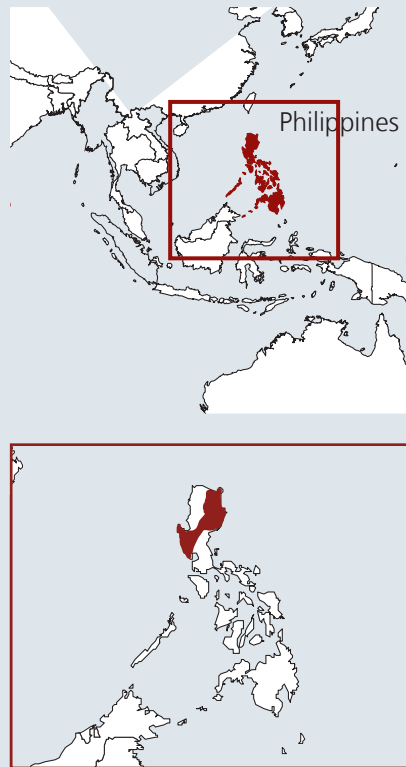
#### Project timeline

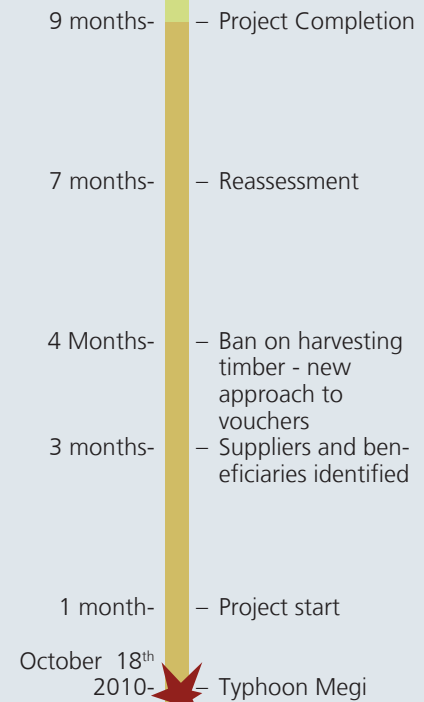
#### Project description

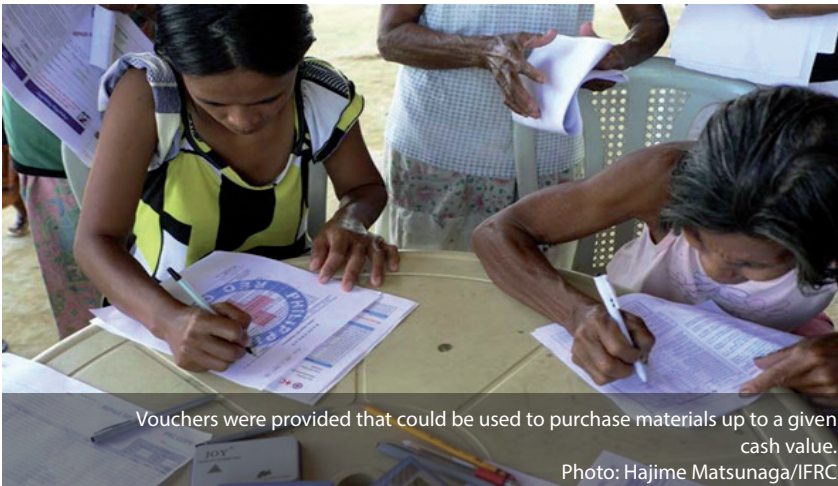
Vouchers were provided that could be used to purchase materials up to a given cash value.

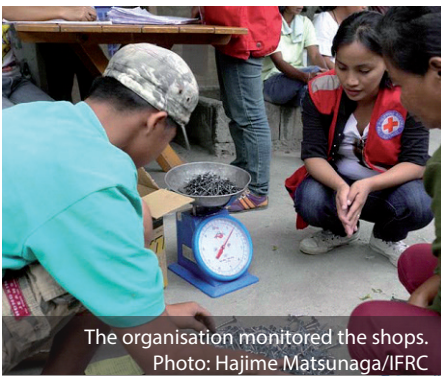
The organisation monitored the shops.  
Photo: Hajime Matsunaga/IFRC

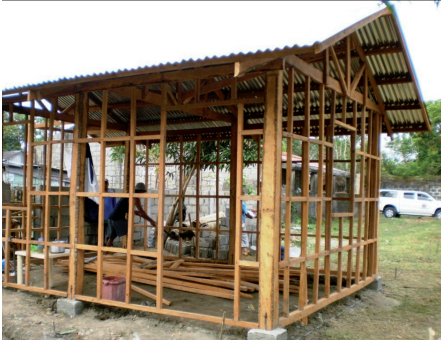
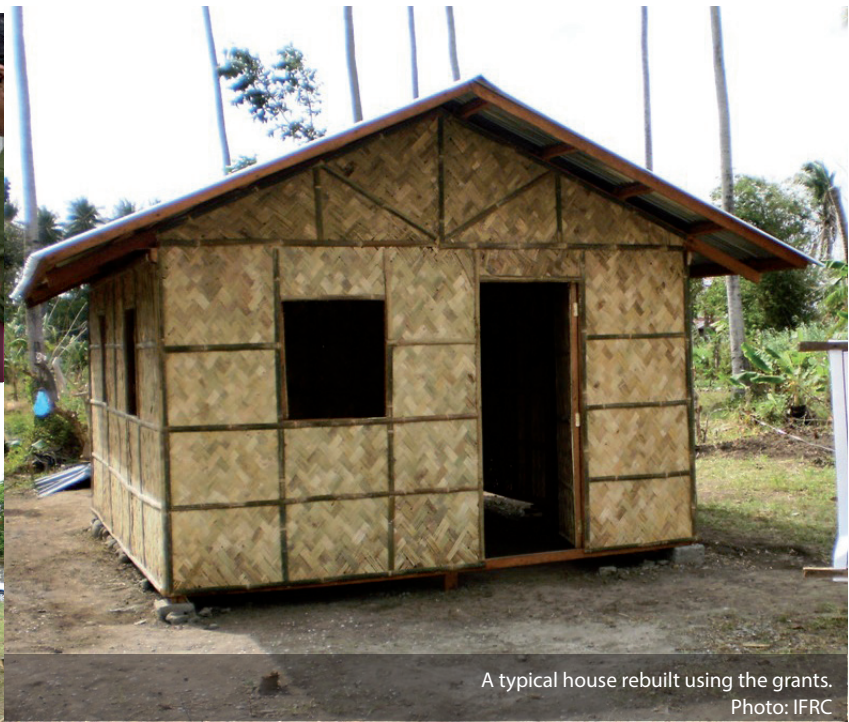
A typical house rebuilt using the grants.  
Photo: IFRC

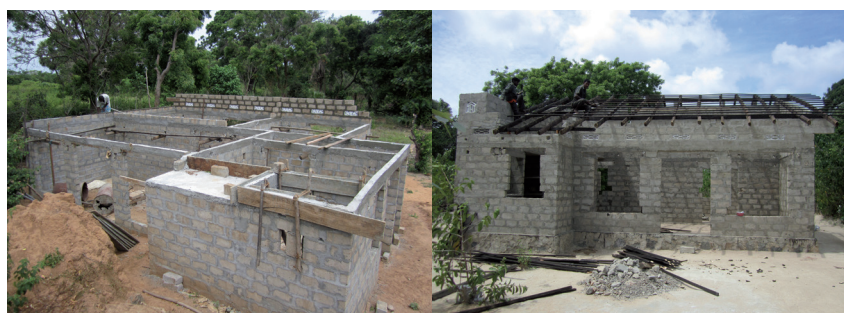
Grants were phased, and each grant was conditional upon the previous level of construction being attained.  
Photo: Ganga Kariyawasam, IFRC

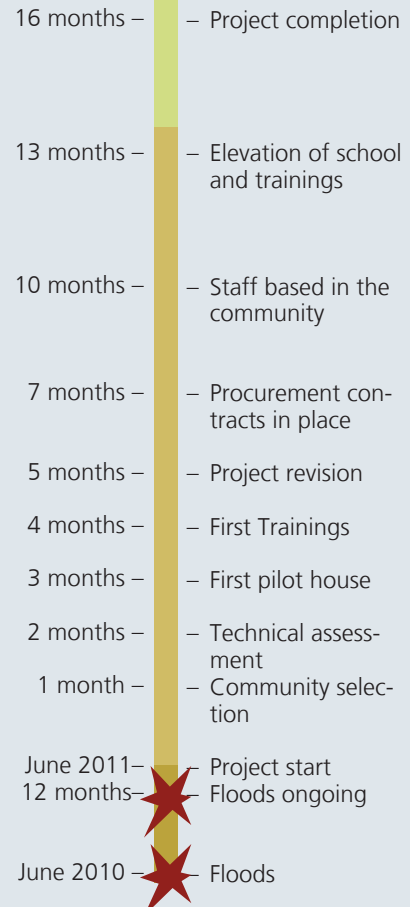
### Project description

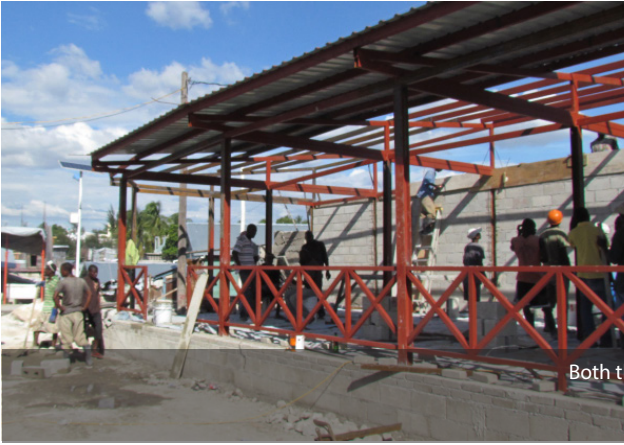
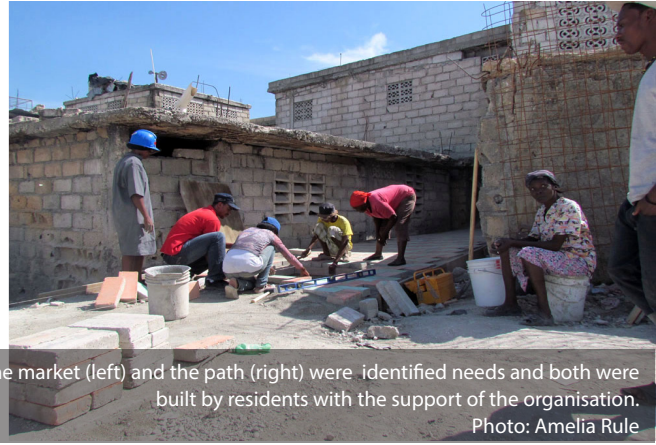
Both the market (left) and the path (right) were identified needs and both were built by residents with the support of the organisation.  
Photo: Amelia Rule

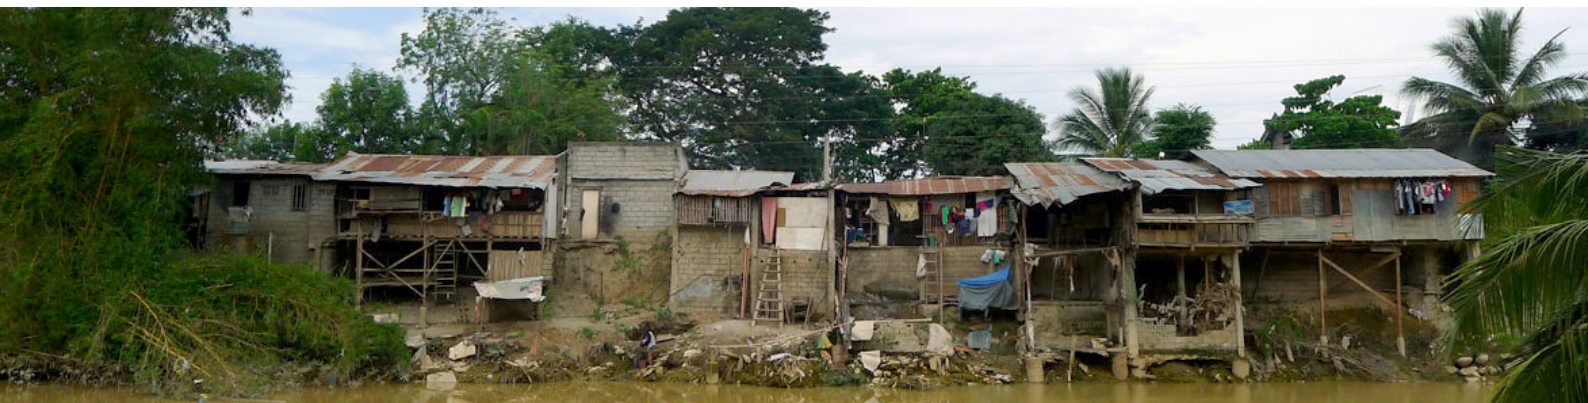
Before the cyclone, many families were living in locations that were vulnerable to storms and flooding, but that had access to livelihoods. The government declared that some of these were "no build" zones, and new sites had to be identified.

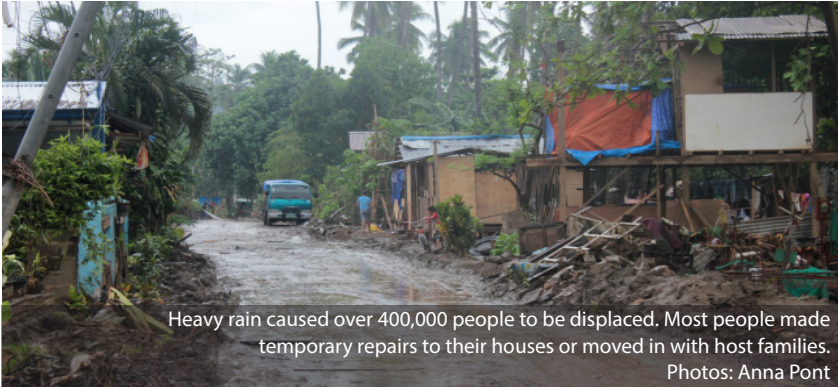
Heavy rain caused over 400,000 people to be displaced. Most people made temporary repairs to their houses or moved in with host families.  
Photos: Anna Pont

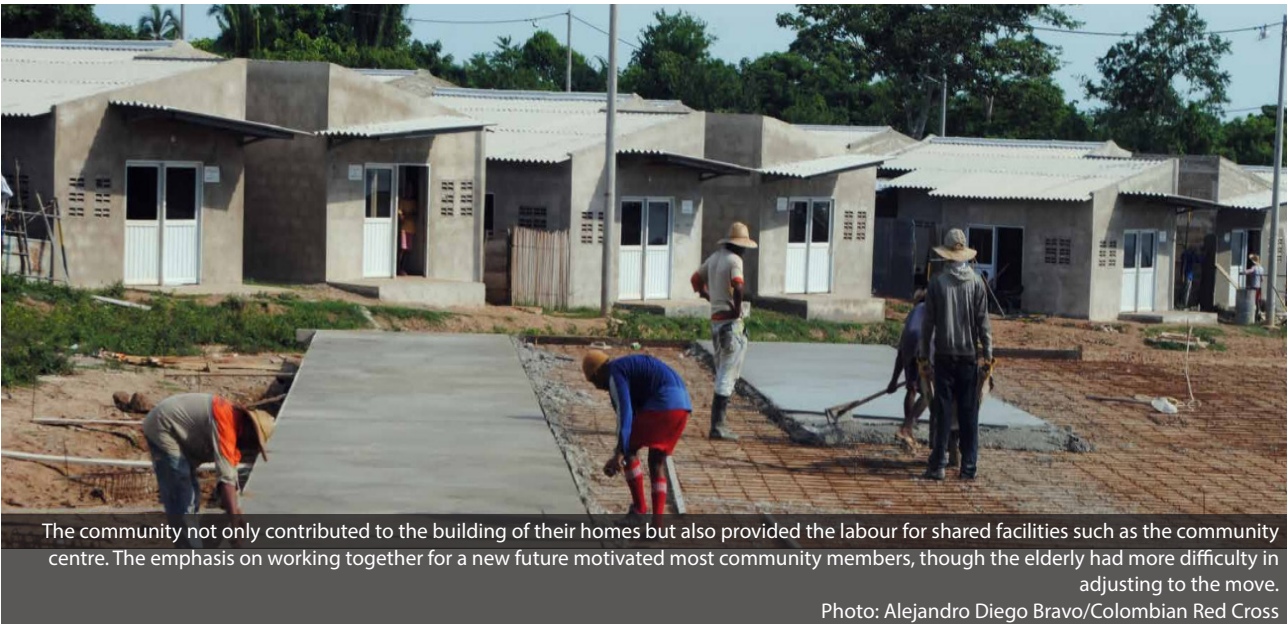
The community not only contributed to the building of their homes but also provided the labour for shared facilities such as the community centre. The emphasis on working together for a new future motivated most community members, though the elderly had more difficulty in adjusting to the move.

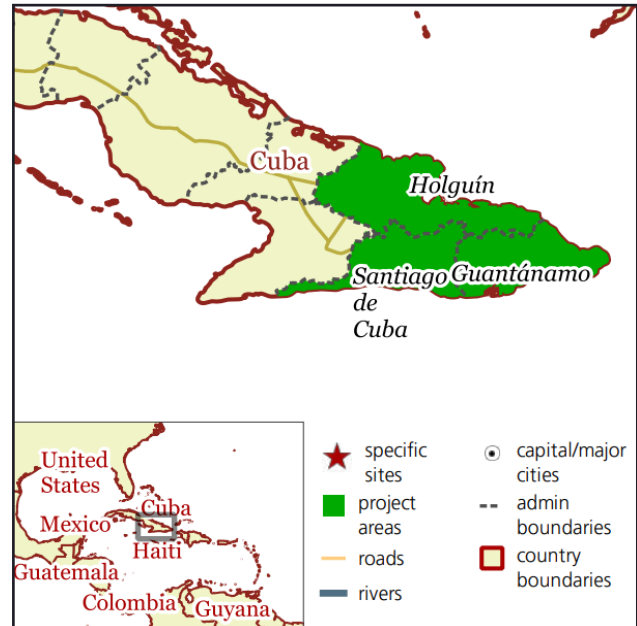
### Emergency timeline:

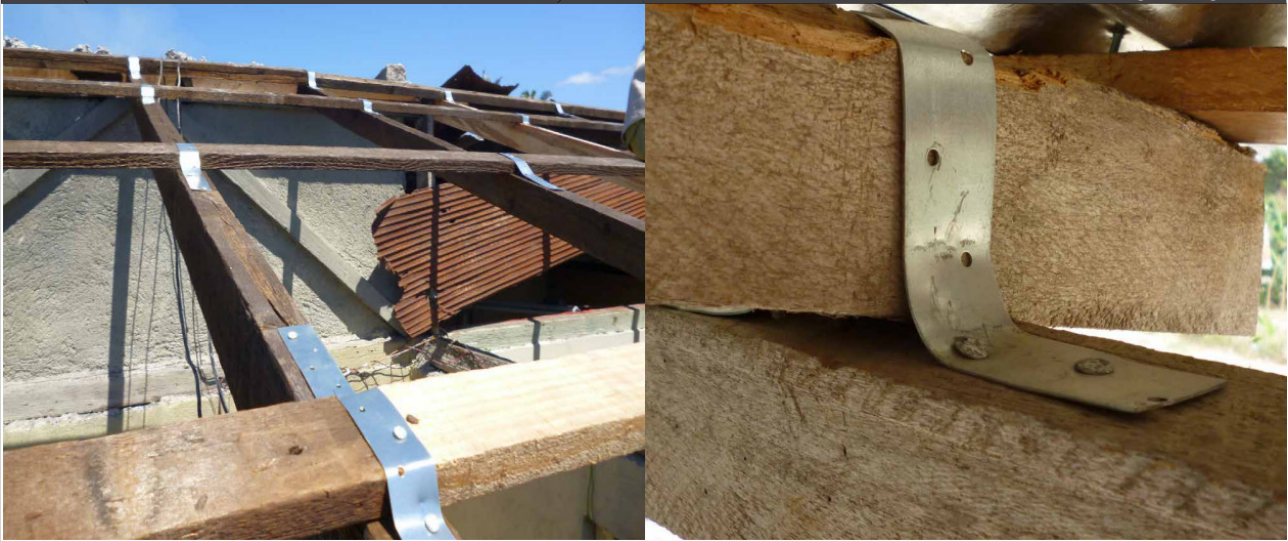
### Situation before the disaster

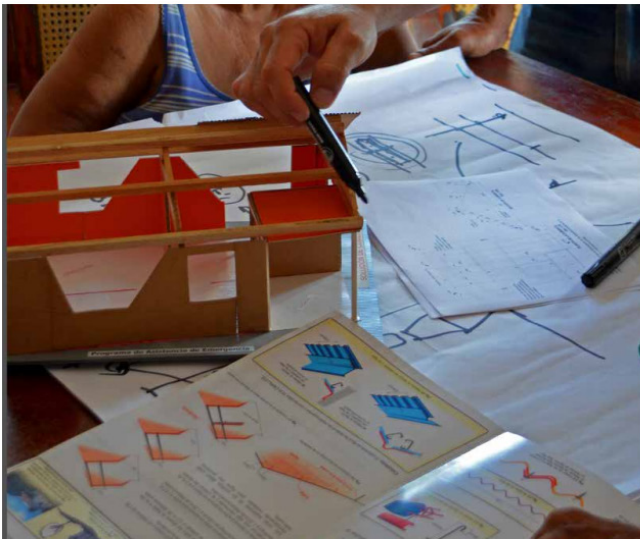
Organisation A ran trainings to instruct beneficiaries on safer and stronger construction techniques. Teaching aids included posters and scale-model houses. Photo: Ictiandro Castillo. Graphic: CARE International.

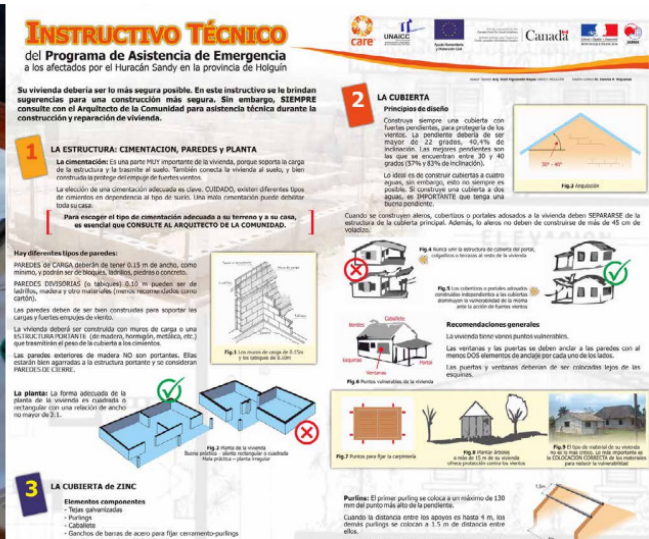
construction materials at reduced prices, and to be able to repair their homes with the receipt of the roofing kit.

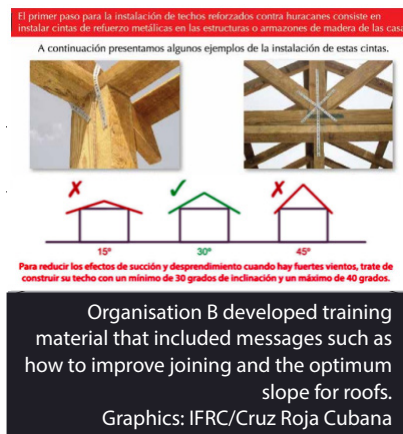
## Disaster Risk Reduction (DRR)

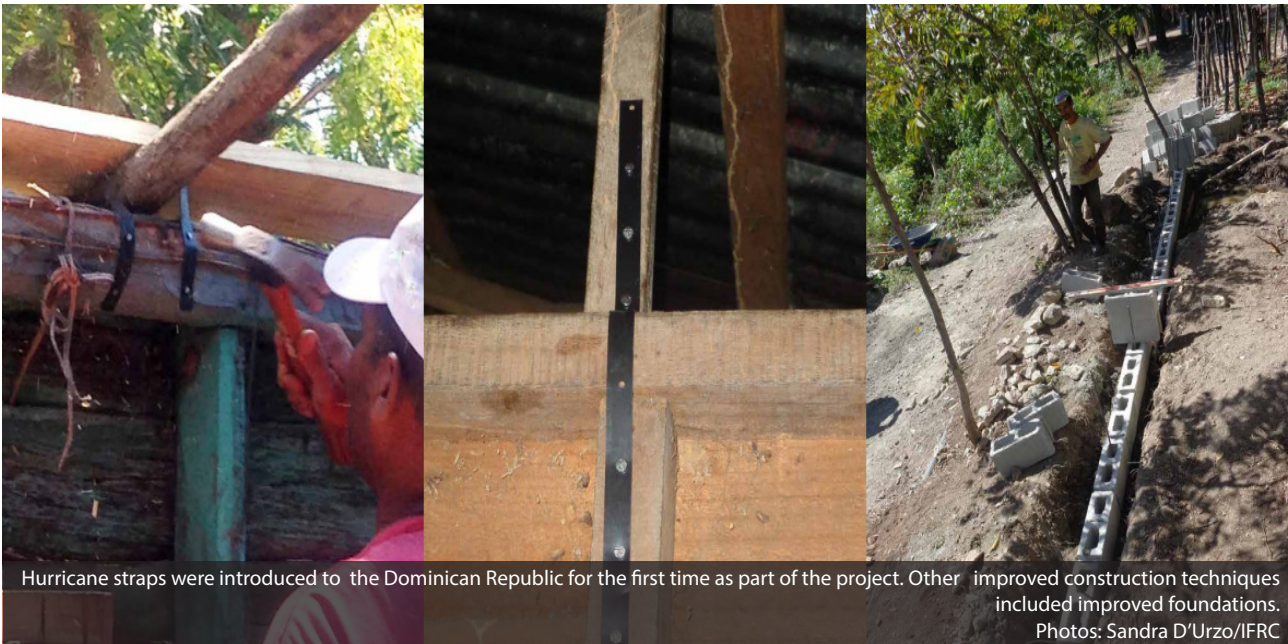
Hurricane straps were introduced to the Dominican Republic for the first time as part of the project. Other improved construction techniques included improved foundations. Photos: Sandra D'Urzo/IFRC

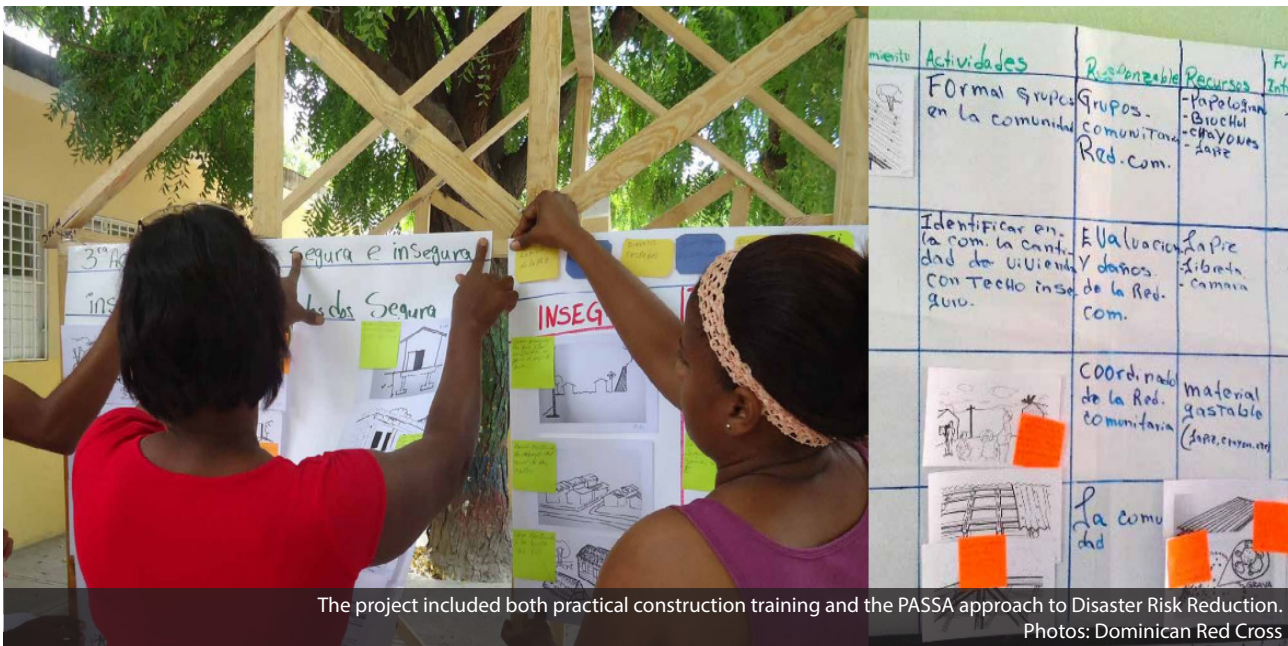
The project included both practical construction training and the PASSA approach to Disaster Risk Reduction. Photos: Dominican Red Cross

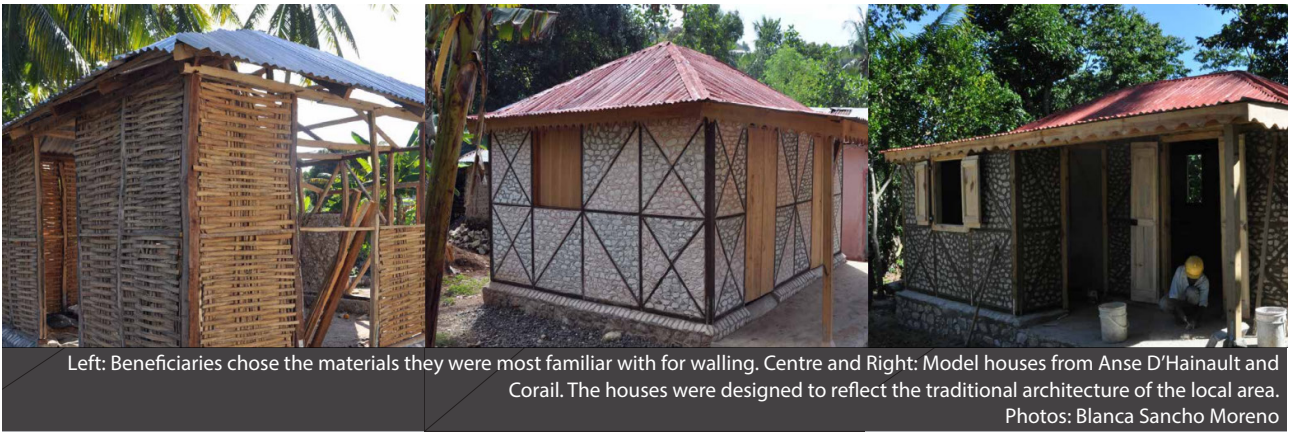
Left: Beneficiaries chose the materials they were most familiar with for walling. Centre and Right: Model houses from Anse D'Hainault and Corail. The houses were designed to reflect the traditional architecture of the local area. Photos: Blanca Sancho Moreno

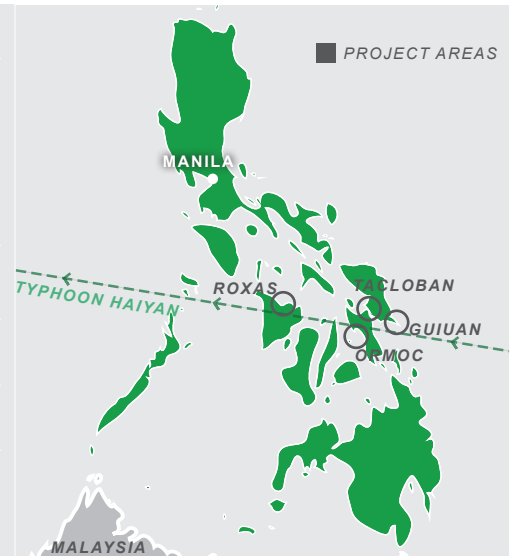
<b>MATERIALS COST</b>	<b>USD 300</b> for Recovery Shelter Kits. <b>USD 1,190-1,860</b> for Transitional Shelters.
<b>PROJECT COST</b>	<b>USD 385</b> for Recovery Shelter Kits. <b>USD 1,960</b> for Transitional Shelters.

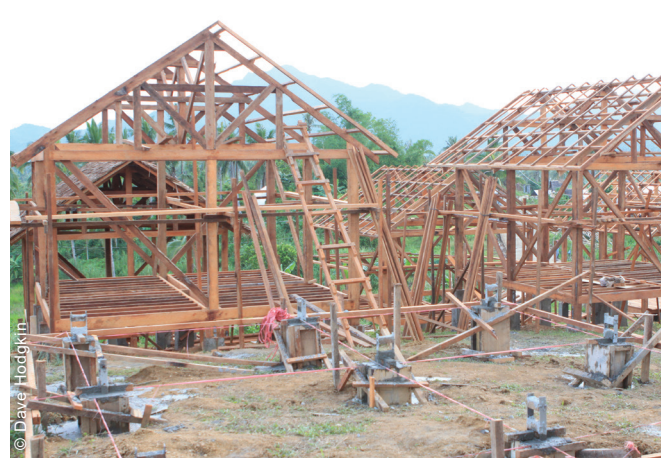
In a few cases, transitional shelters were built in resettlement sites, such as this one in Tacloban, rather than on people's original plots.

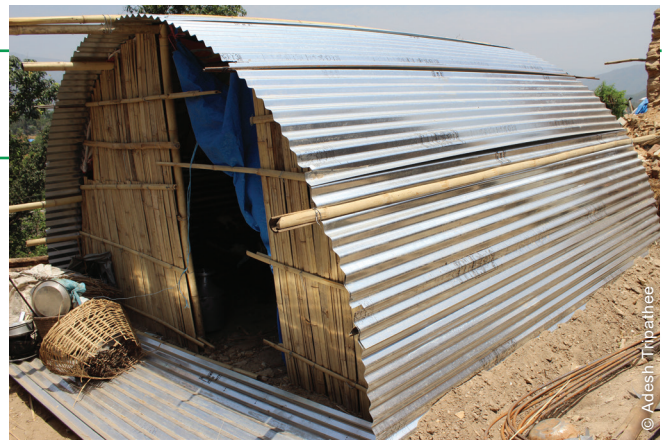
Some people used the materials provided to build temporary shelters according to the organization's design.

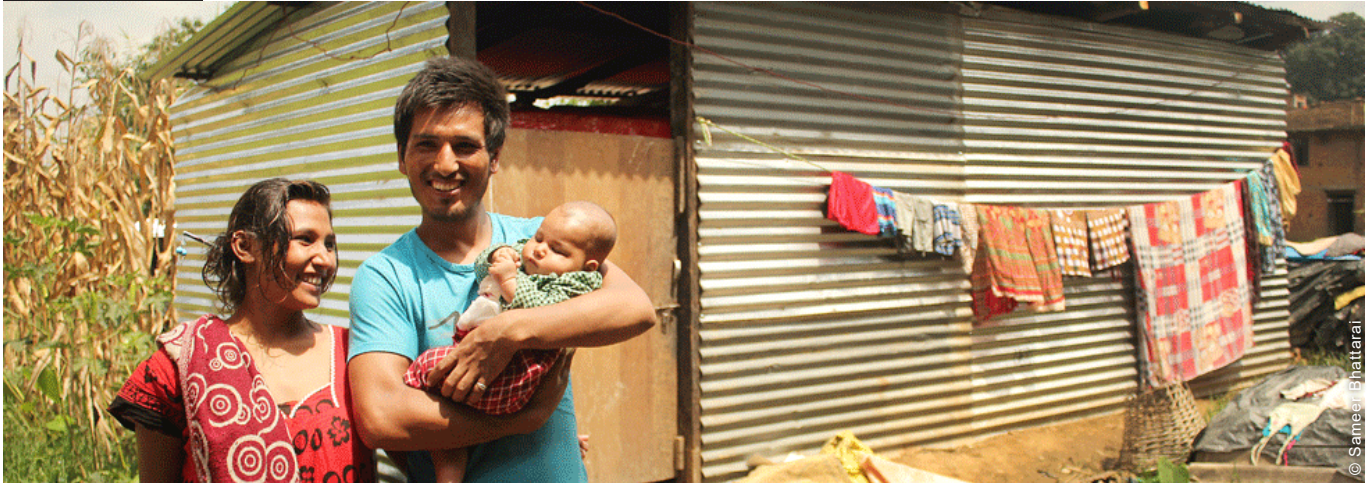
Although a set design was provided by the organization, many people adopted their own designs, using the materials provided with the kits, along with salvaged materials, to meet their own specific needs.

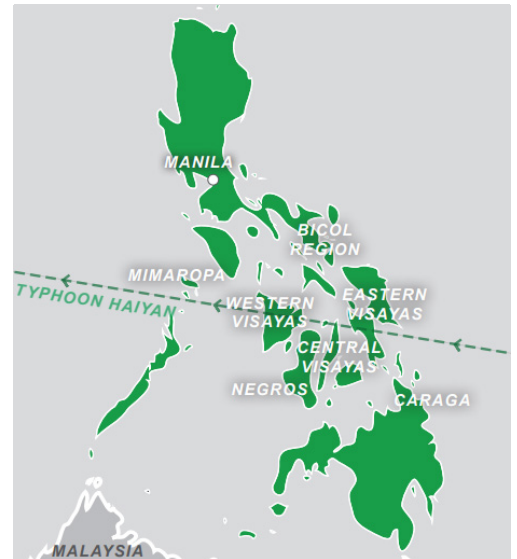
Map highlighting the path of typhoon Haiyan and the most affected regions, including: Eastern Visayas: Biliran, Leyte, Southern Leyte, Samar, Northern Samar, Eastern Samar. Central Visayas: Cebu, Bohol. Negros: Negros Occidental, Negros Oriental. Western Visayas: Aklan, Capiz, Iloilo, Antique, Guimaras. Mimaropa: Palawan, Occidental Mindoro, Oriental Mindoro, Romblon. Bicol Region: Masbate, Sorsogon. Caraga: Dinagar Islands, Surigao del Norte, Camiguin.

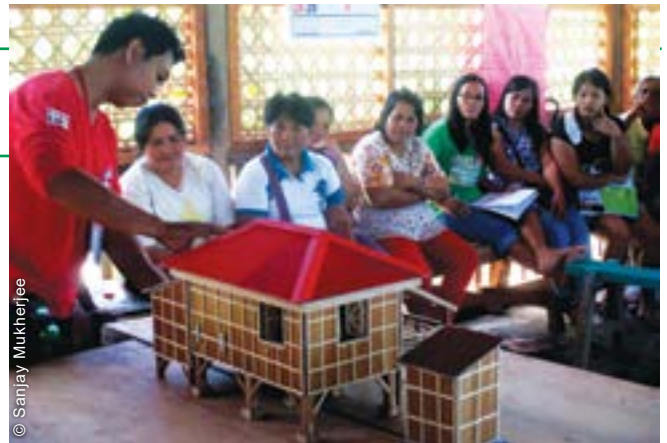
Core shelters and latrines were built to a set design, which was presented at community meetings to explain its features and receive feedback.
