# SHELTER PROJECTS

## RCRC edition

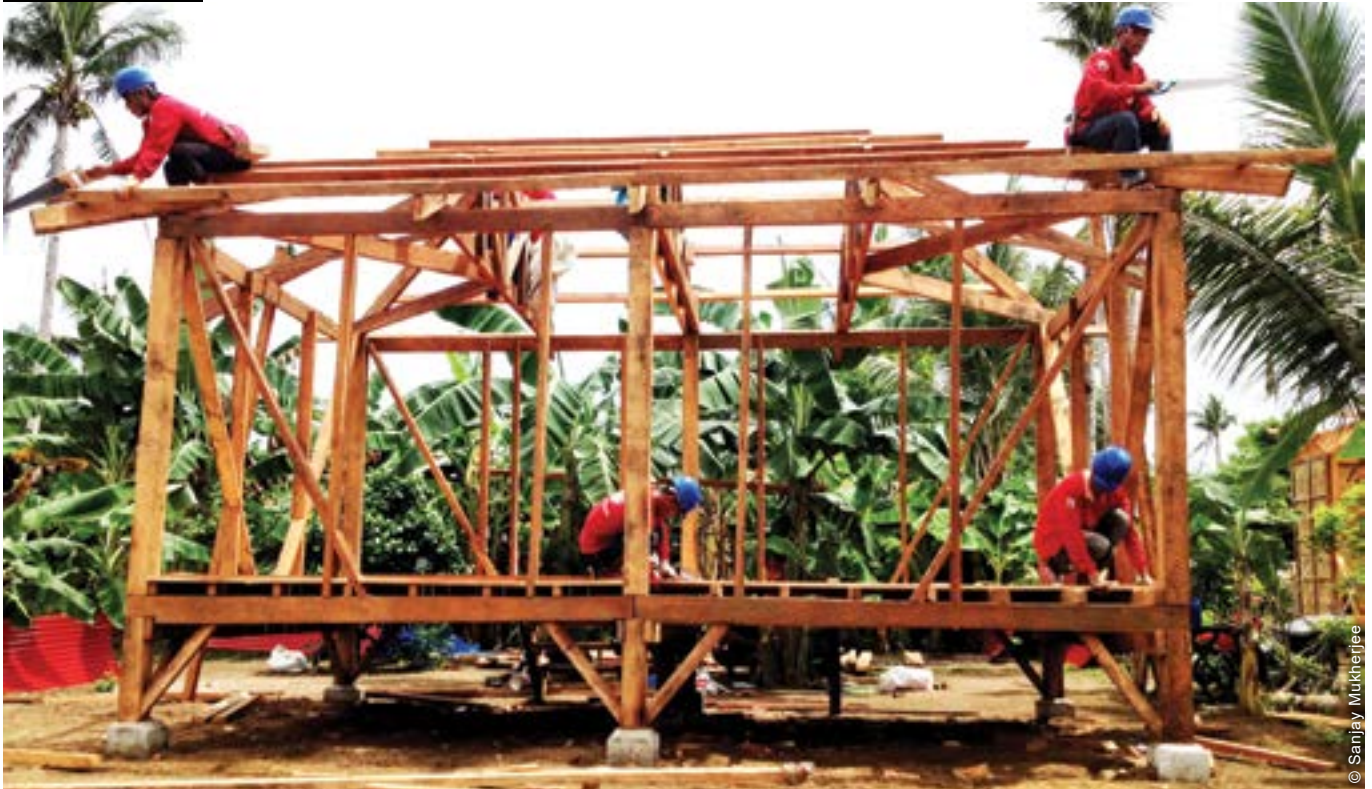
Core shelters were built in several batches by construction teams that included the beneficiaries. Material supply and monitoring were managed by the organization.

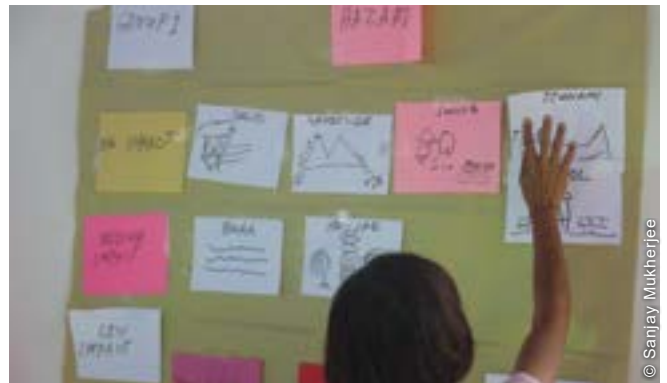
In the second phase, the project used a community-led approach to analyse different hazards and their impact on the communities (PASSA approach).

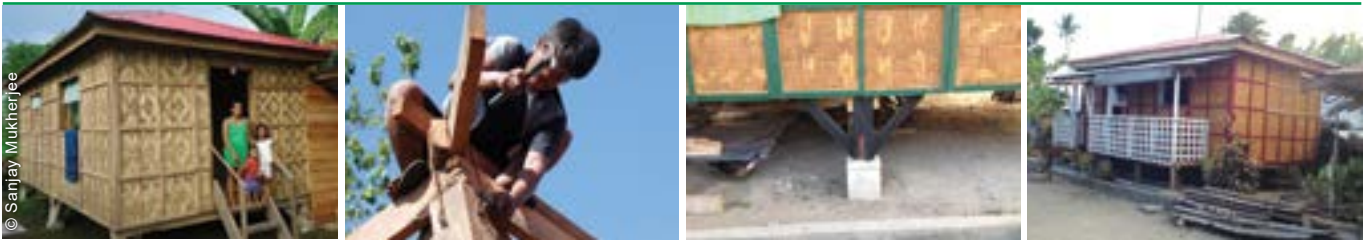
Safer building practices were promoted, such as strapping of roof structures, bracing and proper detailing of the foundations (raised and made of reinforced concrete).

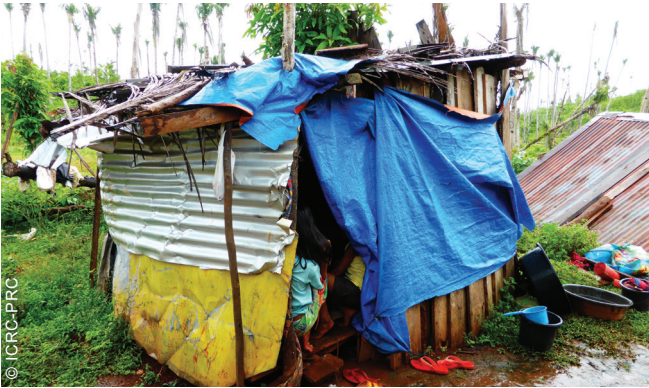
In the aftermath of the typhoon, affected people built makeshift shelters.

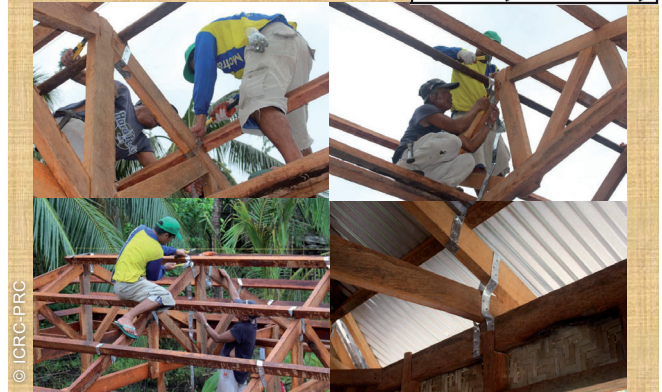
The project had a strong focus on safer construction techniques.

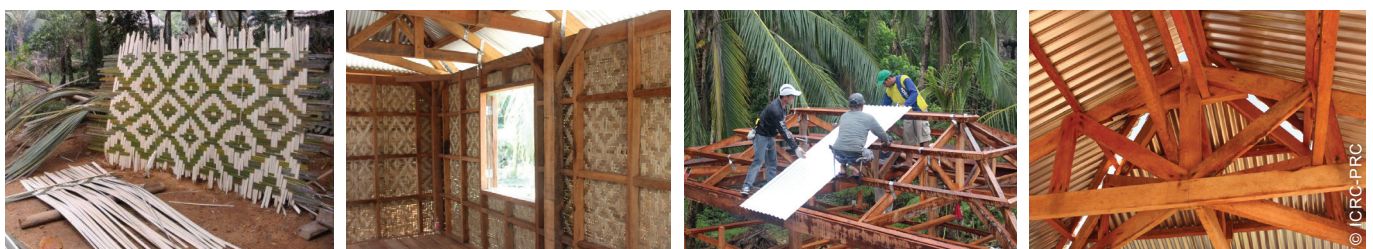
The project used locally available materials (e.g. the amakan sheet, left) and safe construction techniques, including bracing, strong trusses and roof strapping.

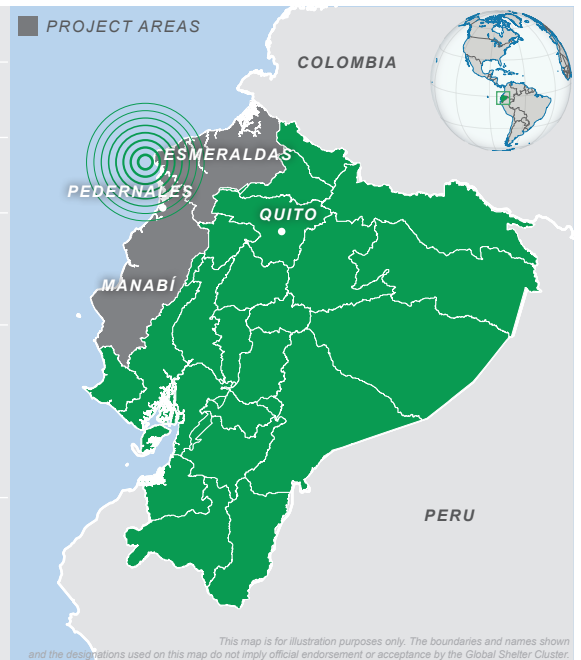
<b>CRISIS</b>	<b>Ecuador Earthquake, 16 April 2016</b>
<b>TOTAL PEOPLE AFFECTED</b>	<b>386,985</b> individuals (on government register)
<b>TOTAL HOUSES DAMAGED</b>	<b>45,455</b> houses damaged or of restricted use
<b>PROJECT LOCATIONS</b>	Across the affected provinces of Manabí and Esmeraldas, plus concentrated activities in Pedernales and Jama municipalities
<b>PROJECT BENEFICIARIES</b>	<b>Over 30,000 households</b> were able to access reconstruction grants <b>Over 5,000 households</b> who received assistance from humanitarian partners were not disqualified from government subsidies
<b>PROJECT OUTPUTS</b>	<b>Advocacy</b> with the government and legal assistance to the Shelter Cluster, enabling affected people to receive shelter and housing support Around <b>420 families received land titles</b> from the local authorities, as of March 2019

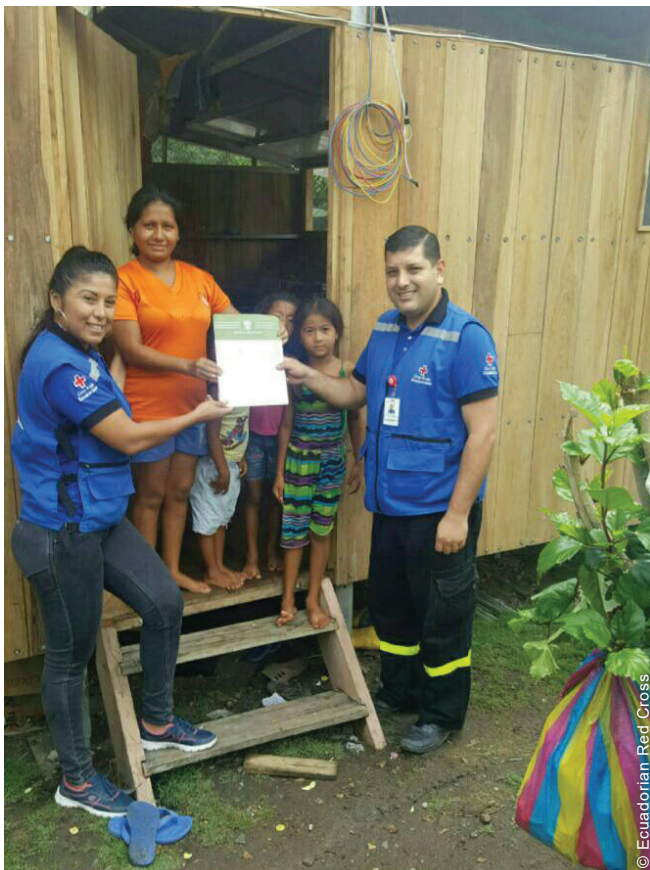
As a direct outcome of this project, 420 land titles were distributed to earthquake-affected households. Support was provided in the form of funding and technical assistance in the process of land tenure regularization.

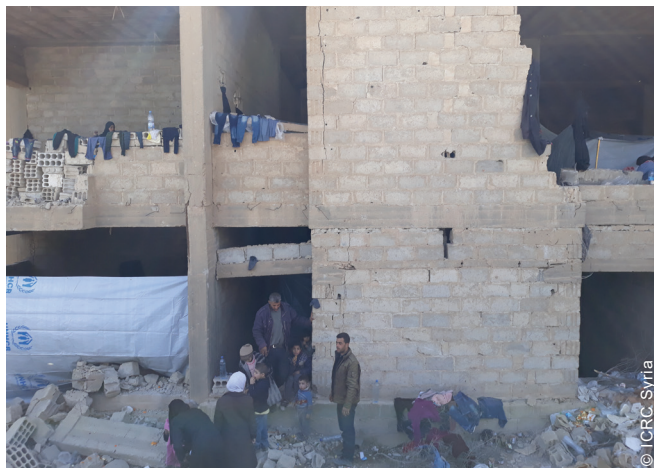
Collective centres included industrial buildings and schools and were often in very poor conditions. Locations were selected by the authorities.

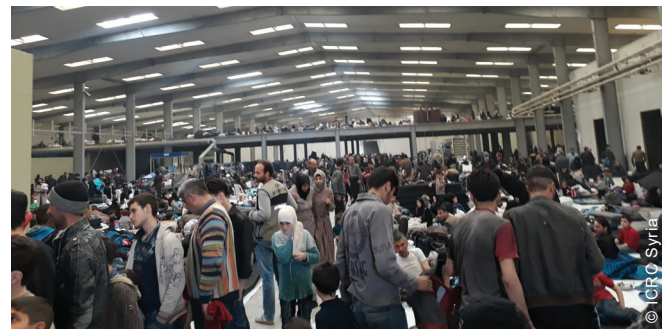
Little to no preparation could be done in the buildings, which soon became overcrowded due to the massive influx.

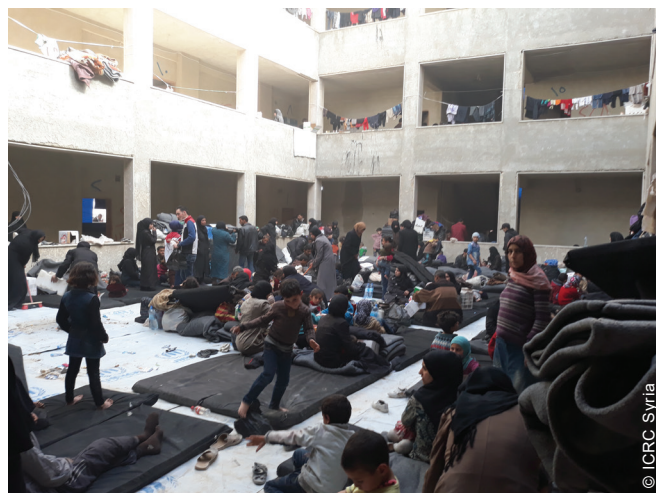
Buildings were upgraded through the set-up of rooms, installation of doors and windows, general repairs, rehabilitation or provision of water, as well as lighting.

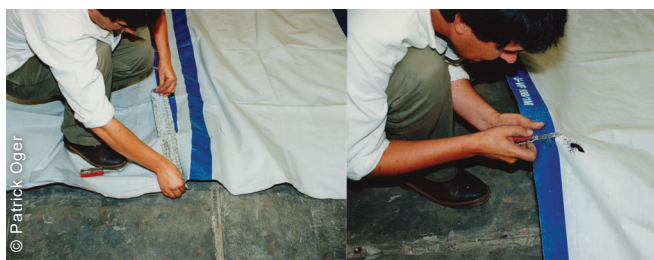
Peeling and scratching tests can be conducted in the field after basic training.

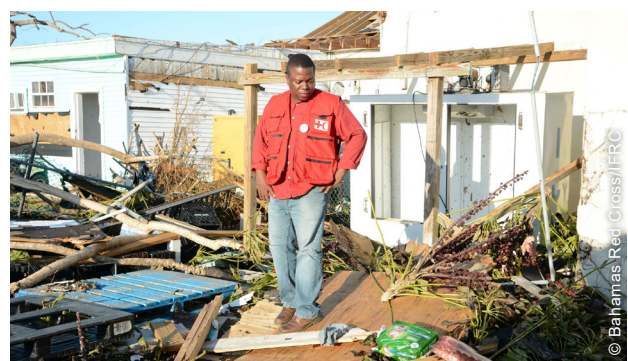
Hurricane Dorian caused extensive damage to homes and infrastructure.

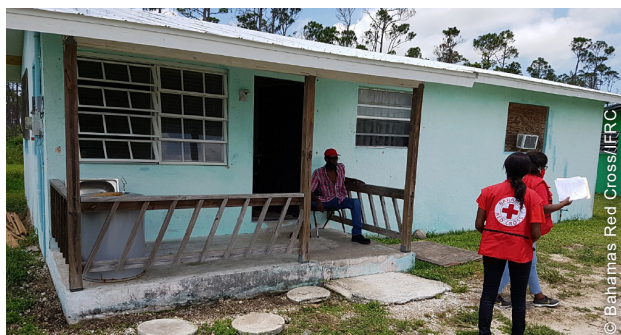
Homes outside of Freeport, the main city on Grand Bahama, are typically timber framed or concrete block single story structures.

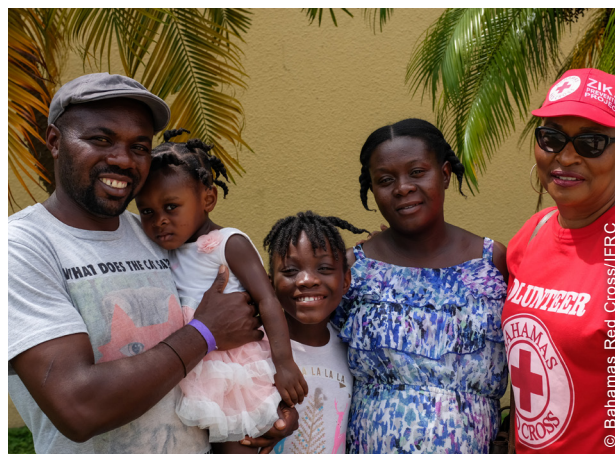
Rental assistance aimed to “buy time” while households recovered their livelihoods, repaired or rebuilt their homes, or found alternative housing arrangements.

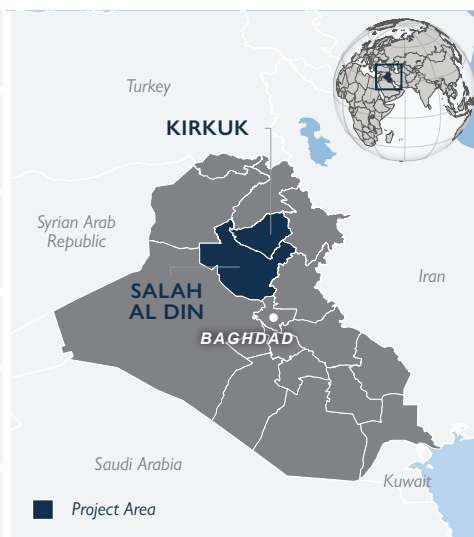
<b>PROJECT COST</b>	<b>USD 4,900 – USD 11,900</b> per HH (dependent on household size and level of damage)

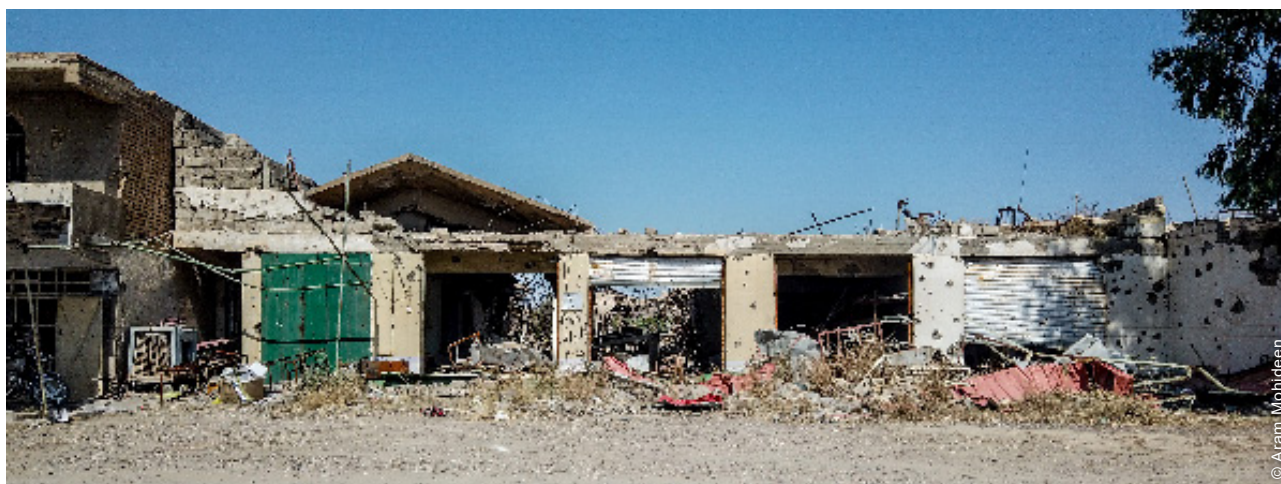
Families with a certain degree of socioeconomic vulnerability were confirmed to participate in shelter technical assessments that validated the level of damage of their home. Through household visits, team members classified the level of damage of the house based on the Iraq National Shelter Cluster Criteria, and verified the ownership of the house and land, either by checking the land deeds (common in urban and peri-urban areas), or by triangulating the information via trusted community members or the Community Working Groups whenever ownership documentation was unavailable (common in rural areas).

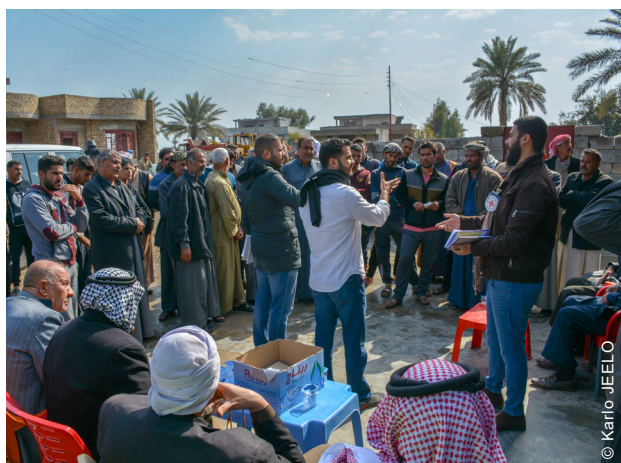
Community Working Groups (CWGs) were formed and were engaged in all stages of the project.

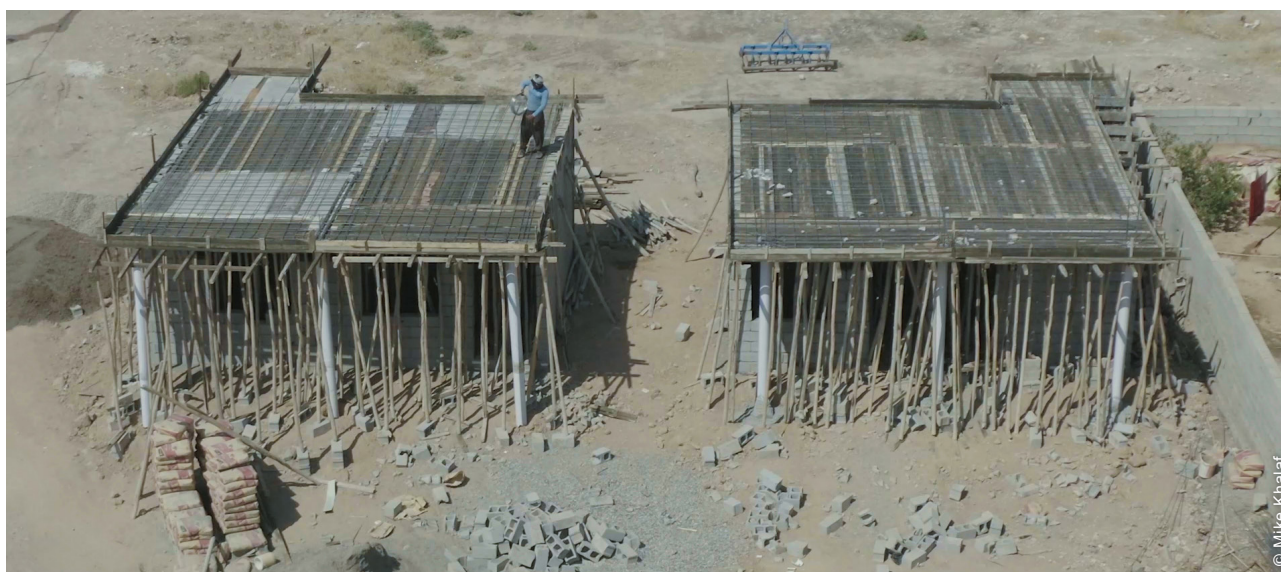
More broadly, the program presented an opportunity to engage with these communities and authorities in the longer term and delve into and jointly address some deeply entrenched protection concerns. While difficult to measure, **community-based projects and the sense that the village or neighborhood as a whole benefited from the program** appear to have **strengthened ties between neighbors**, even though the picture here remains mixed.

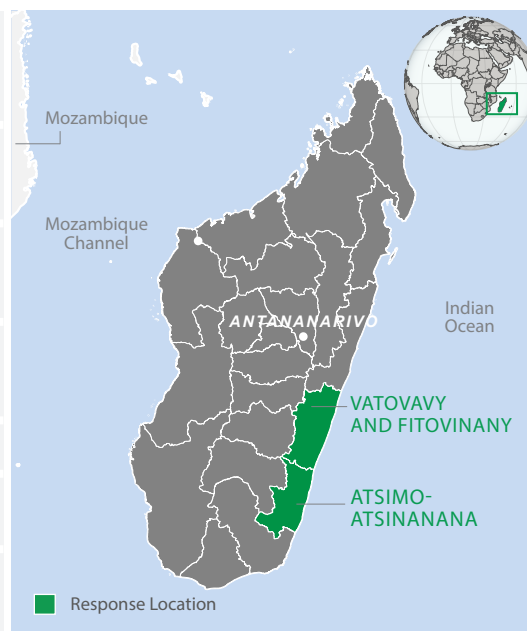
SUMMARY OF THE RESPONSE

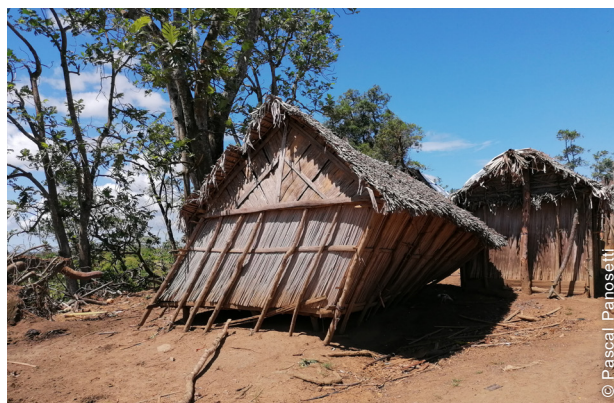
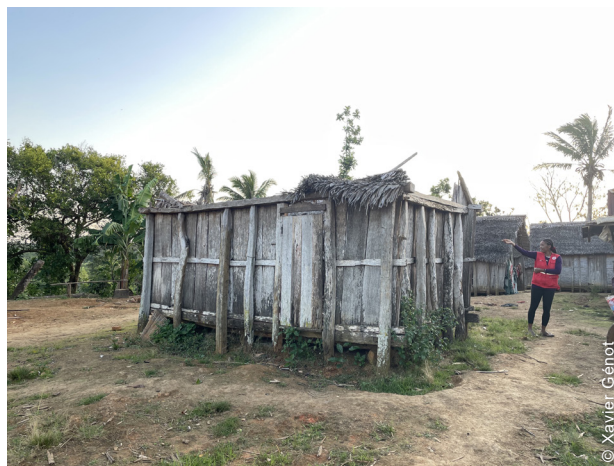
Shelter assessments were carried out for the houses damaged by the impact of the cyclones, March and August 2022.

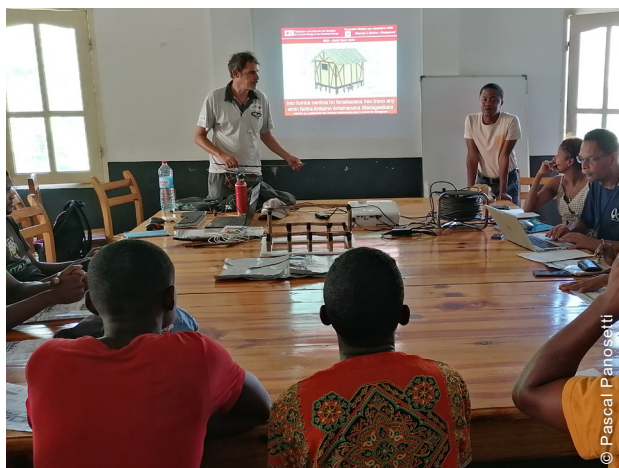
Shelter partners' training on Build Back Safer, March 2022.

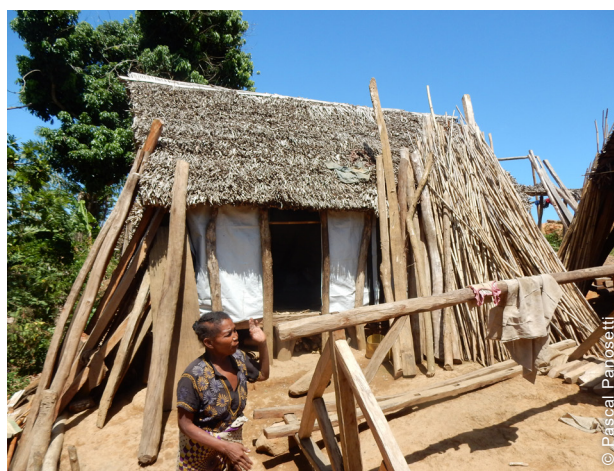
House repairing process with Conditional Cash for Shelter approach.

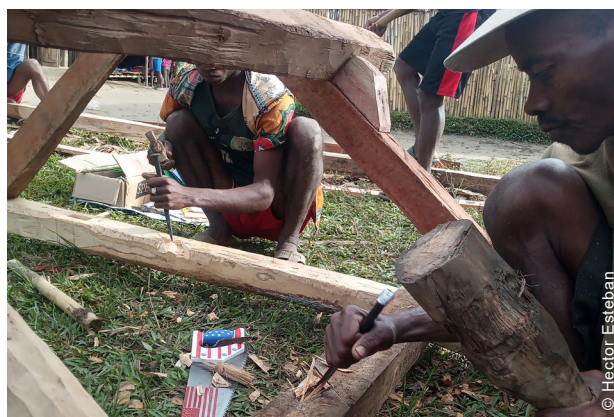
Training of the community carpenters.

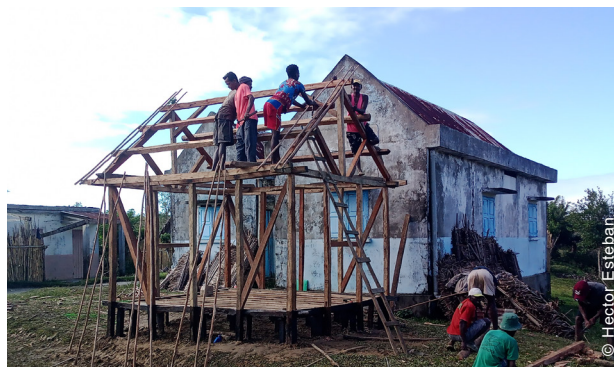
Building of a model house with trained carpenters, Conditional Cash for Shelter program.

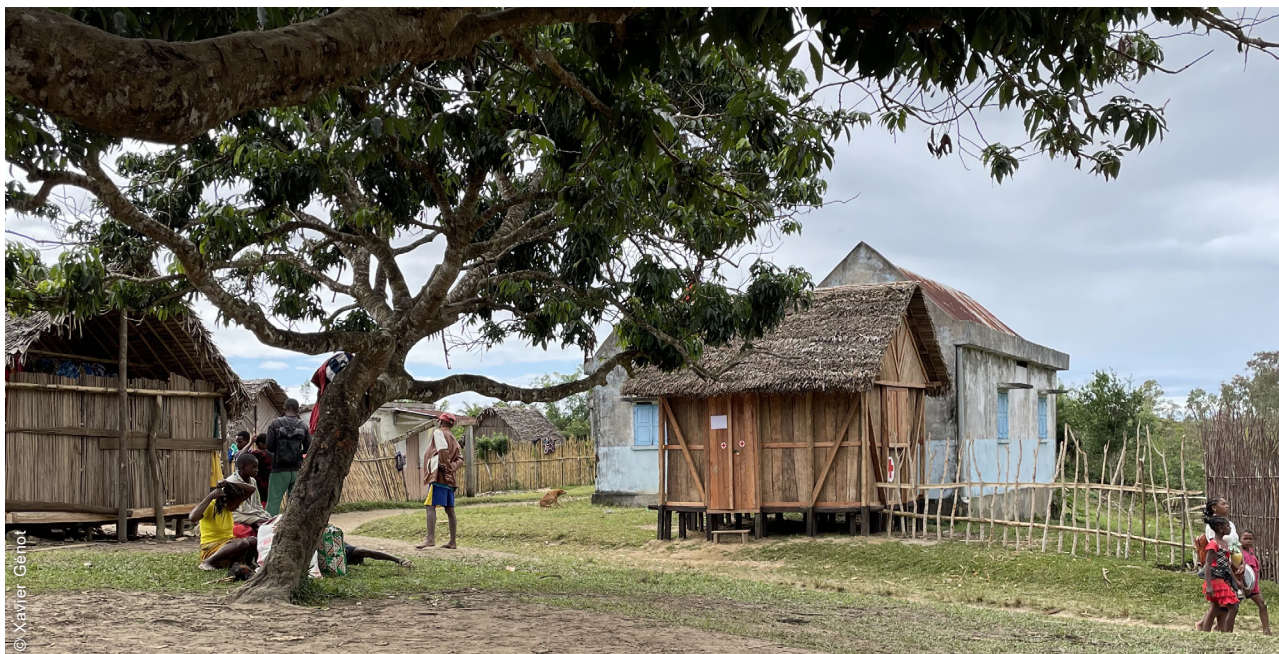
Model house built at the centre of main settlement to enhance safer shelter awareness at community level. It was used for training of volunteers before assisting eligible households.
